REPORT
OF
THE COURT INVESTIGATING

ACCIDENT TO AIR INDIA
BOEING 747 AIRCRAFT VT-EFO,
“KANISHKA”
ON 23RD JUNE 1985

FEBRUARY 26, 1986

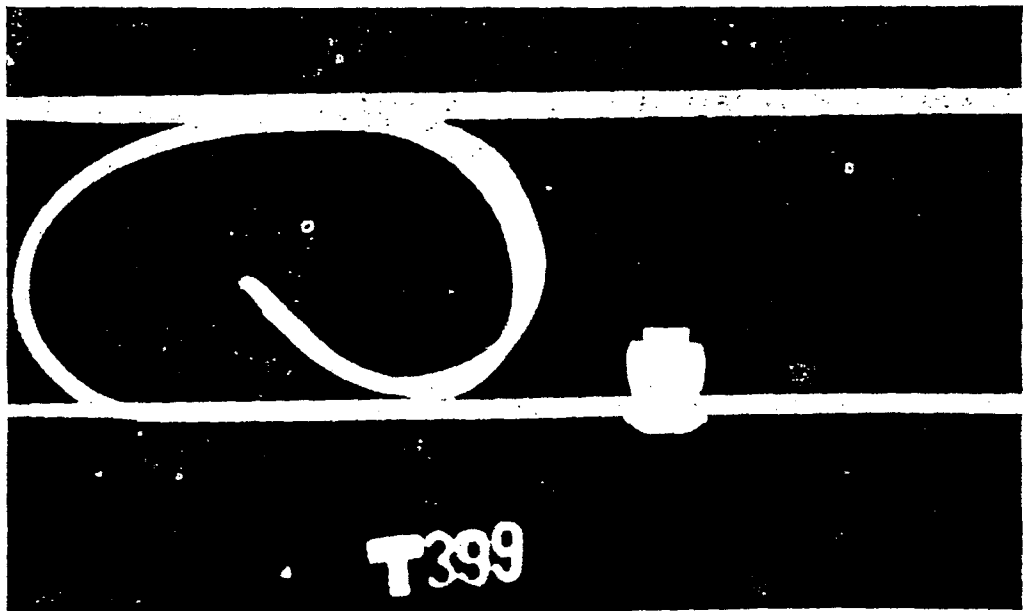
Fig. 399-6. Print from a radiograph of the station (Refer Fig.399-5) showing inward curling.

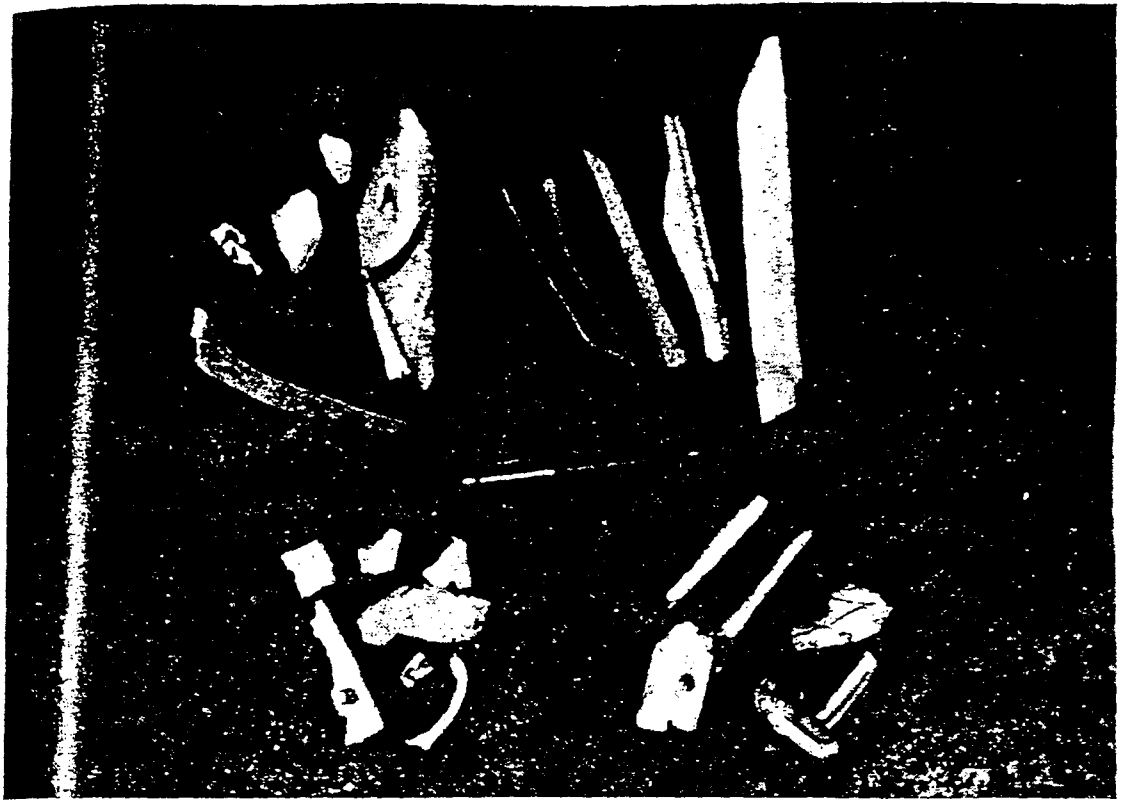
Fig. 399-10. A collection of small fragments recovered from target 399. A : Curved fragment. B : Fragment with reverse slant fracture. C : Spike fragment.

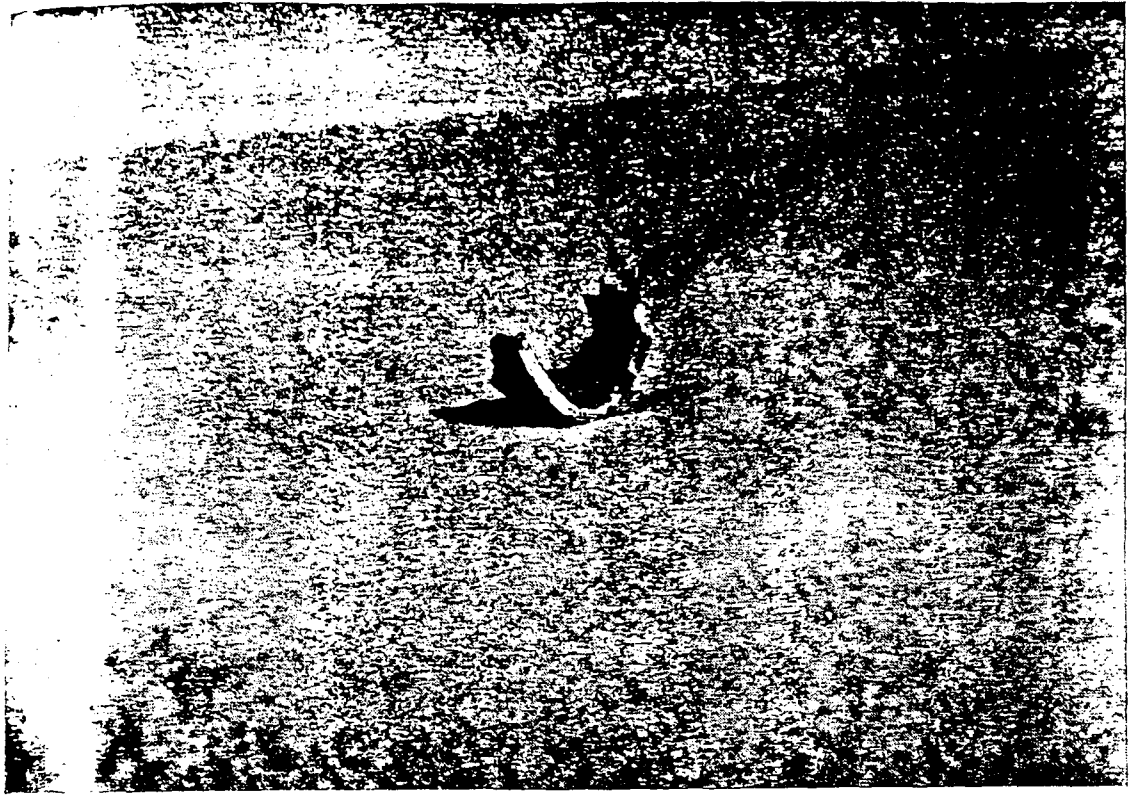
Fig. 362-15. Spikes at the edge of hole no.16, inside the stringer.

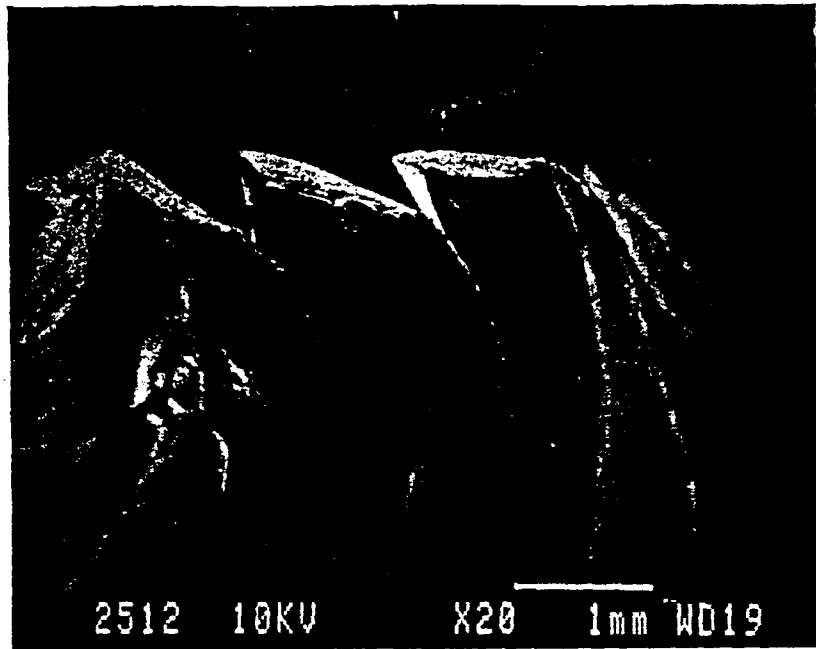
3.2.11.39 Another small fragment was found from the above target. This piece, identified as specimen No. 12 in box No. 1, target 362, has a number of spikes along the edge. A scanning electron micrograph of the spikes is shown in Fig. 362-28. The sides of the spikes on SEM examination revealed elongated dimples as shown in Fig. 362-29, characteristic of shear mode of fracture. Metallography was carried out on the thickness side of this specimen. Fig. 362-30 and 362-31 show the microstructure near the apex of the spike and at the root of the spike respectively. Extensive twinning can be seen in these regions of the spikes.

Fig. 362-28. SEM photograph showing spikes in a fragment from target 362.

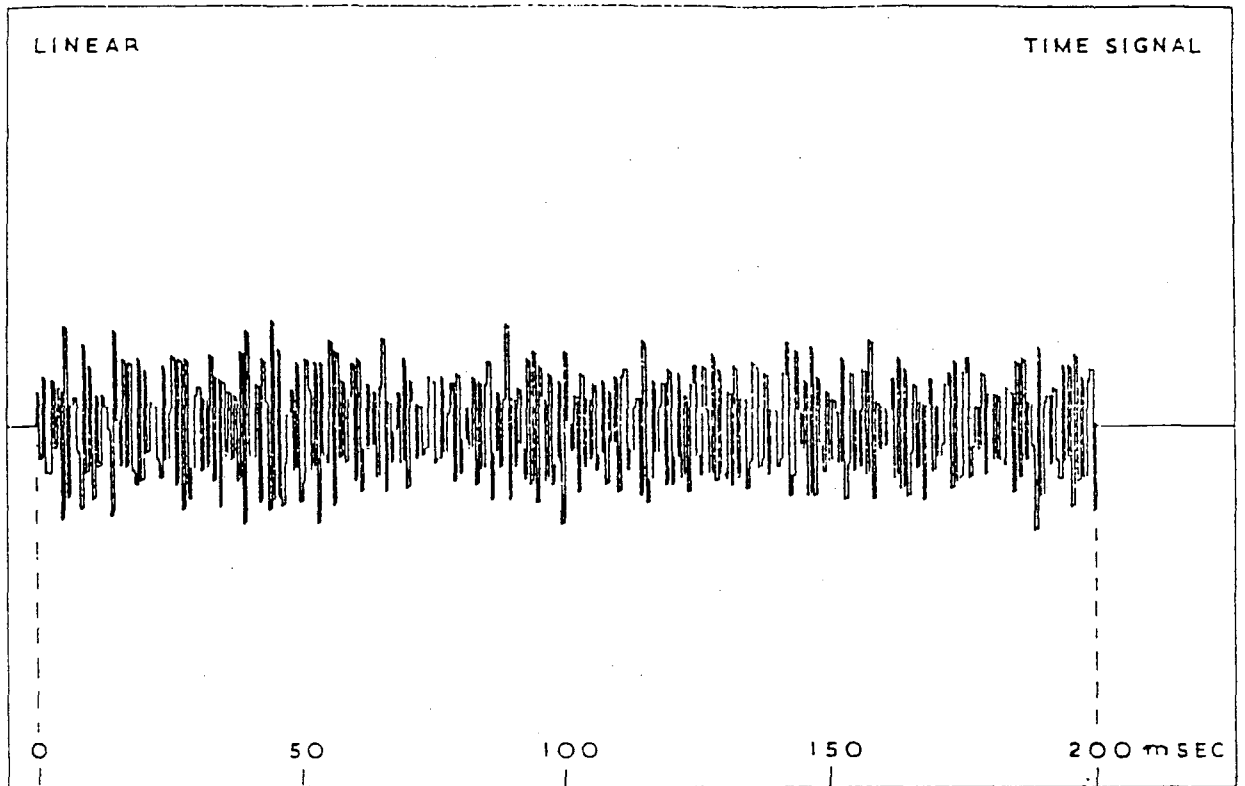
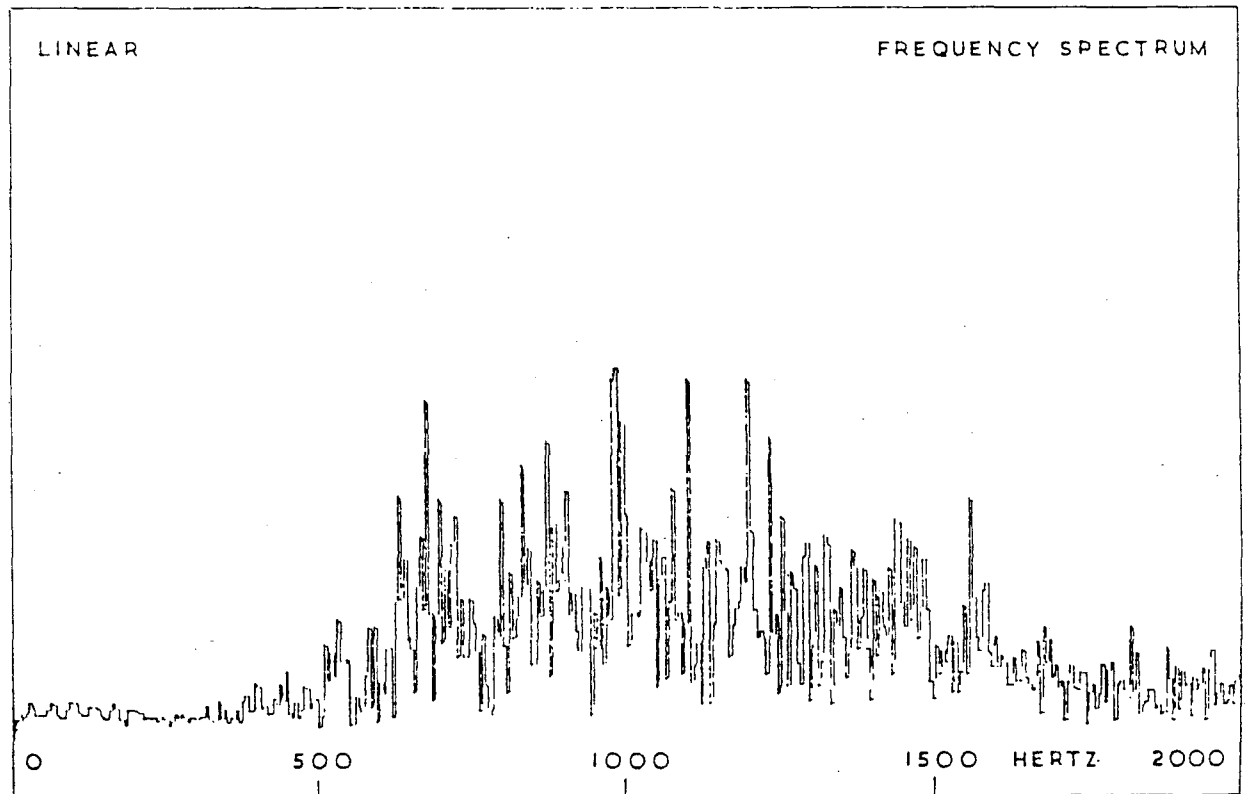
CHANNEL 3: JUST BEFORE BANG

Fig. 2 : KANISHKA — Time Signal and Frequency Spectrum of CAM Channel just before 'bang'.

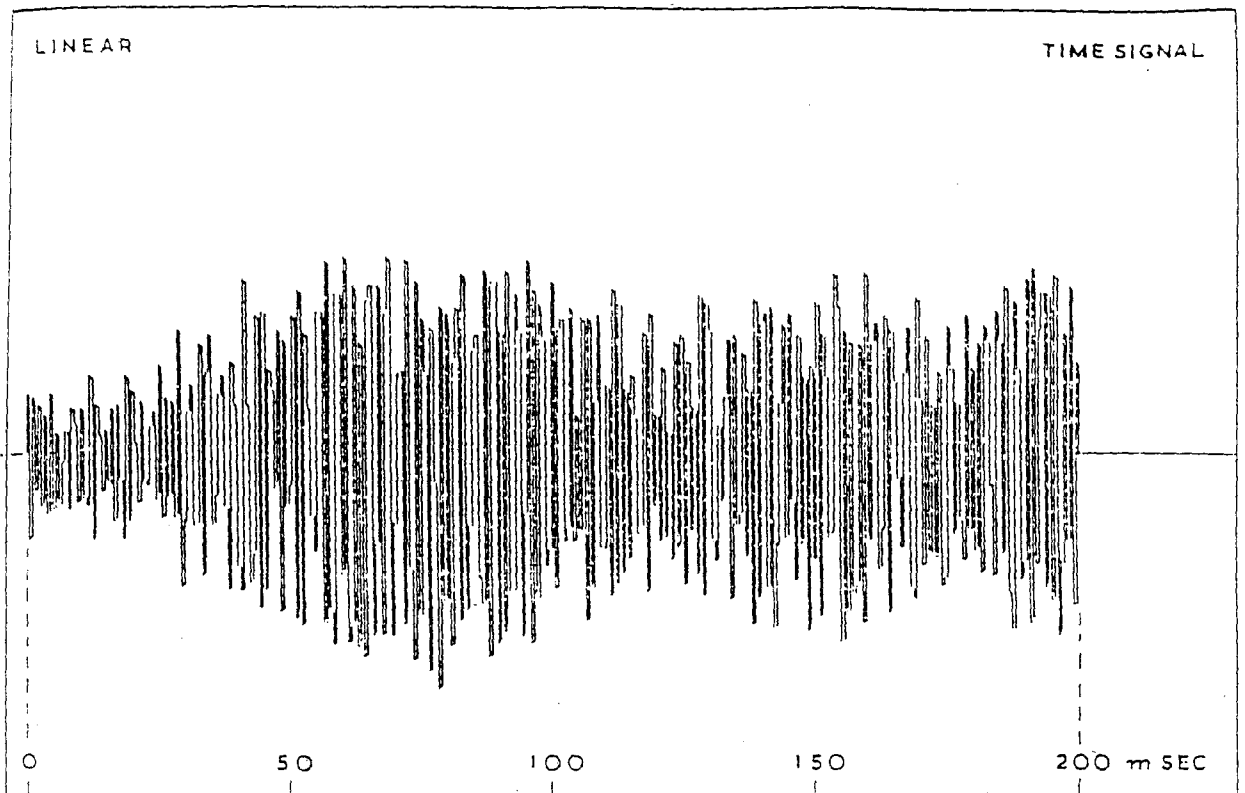
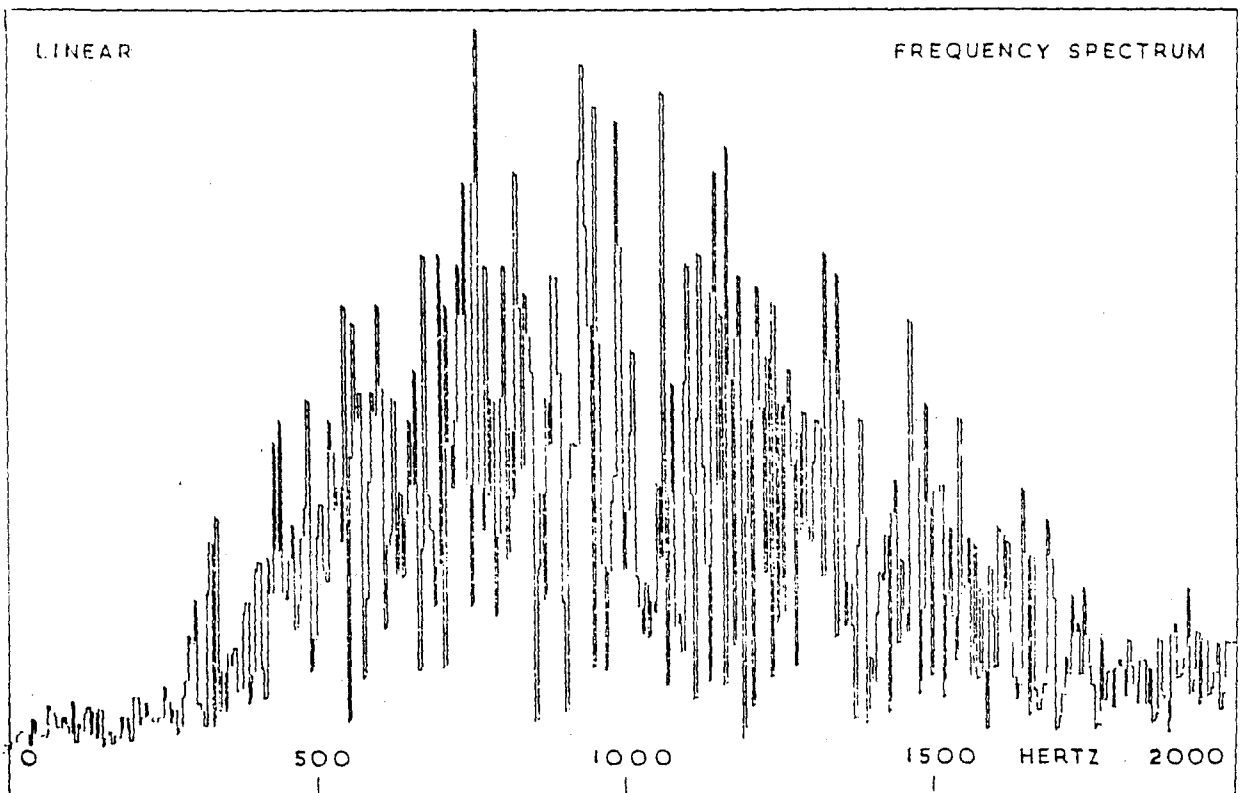
CHANNEL 3: AT BANG

Fig. 3 : KANISHKA -- Time Signal and Frequency Spectrum of CAM Channel at 'bang'.
